**AMETEK U.S.
GAUGE DIVISION**
SELLERSVILLE

**DEEP AQUIFER (SOUTH)
GROUNDWATER
ANALYTICAL RESULTS
VOC AND 1,4-DIOXANE
2013 TO 2014**

**DEEP AQUIFER (NORTH)
GROUNDWATER
ANALYTICAL RESULTS
VOC AND 1,4-DIOXANE
2013 TO 2014**

Drawing Title
**DEEP AQUIFER (SOUTH)
GROUNDWATER
CONTOURS
APRIL 2014**

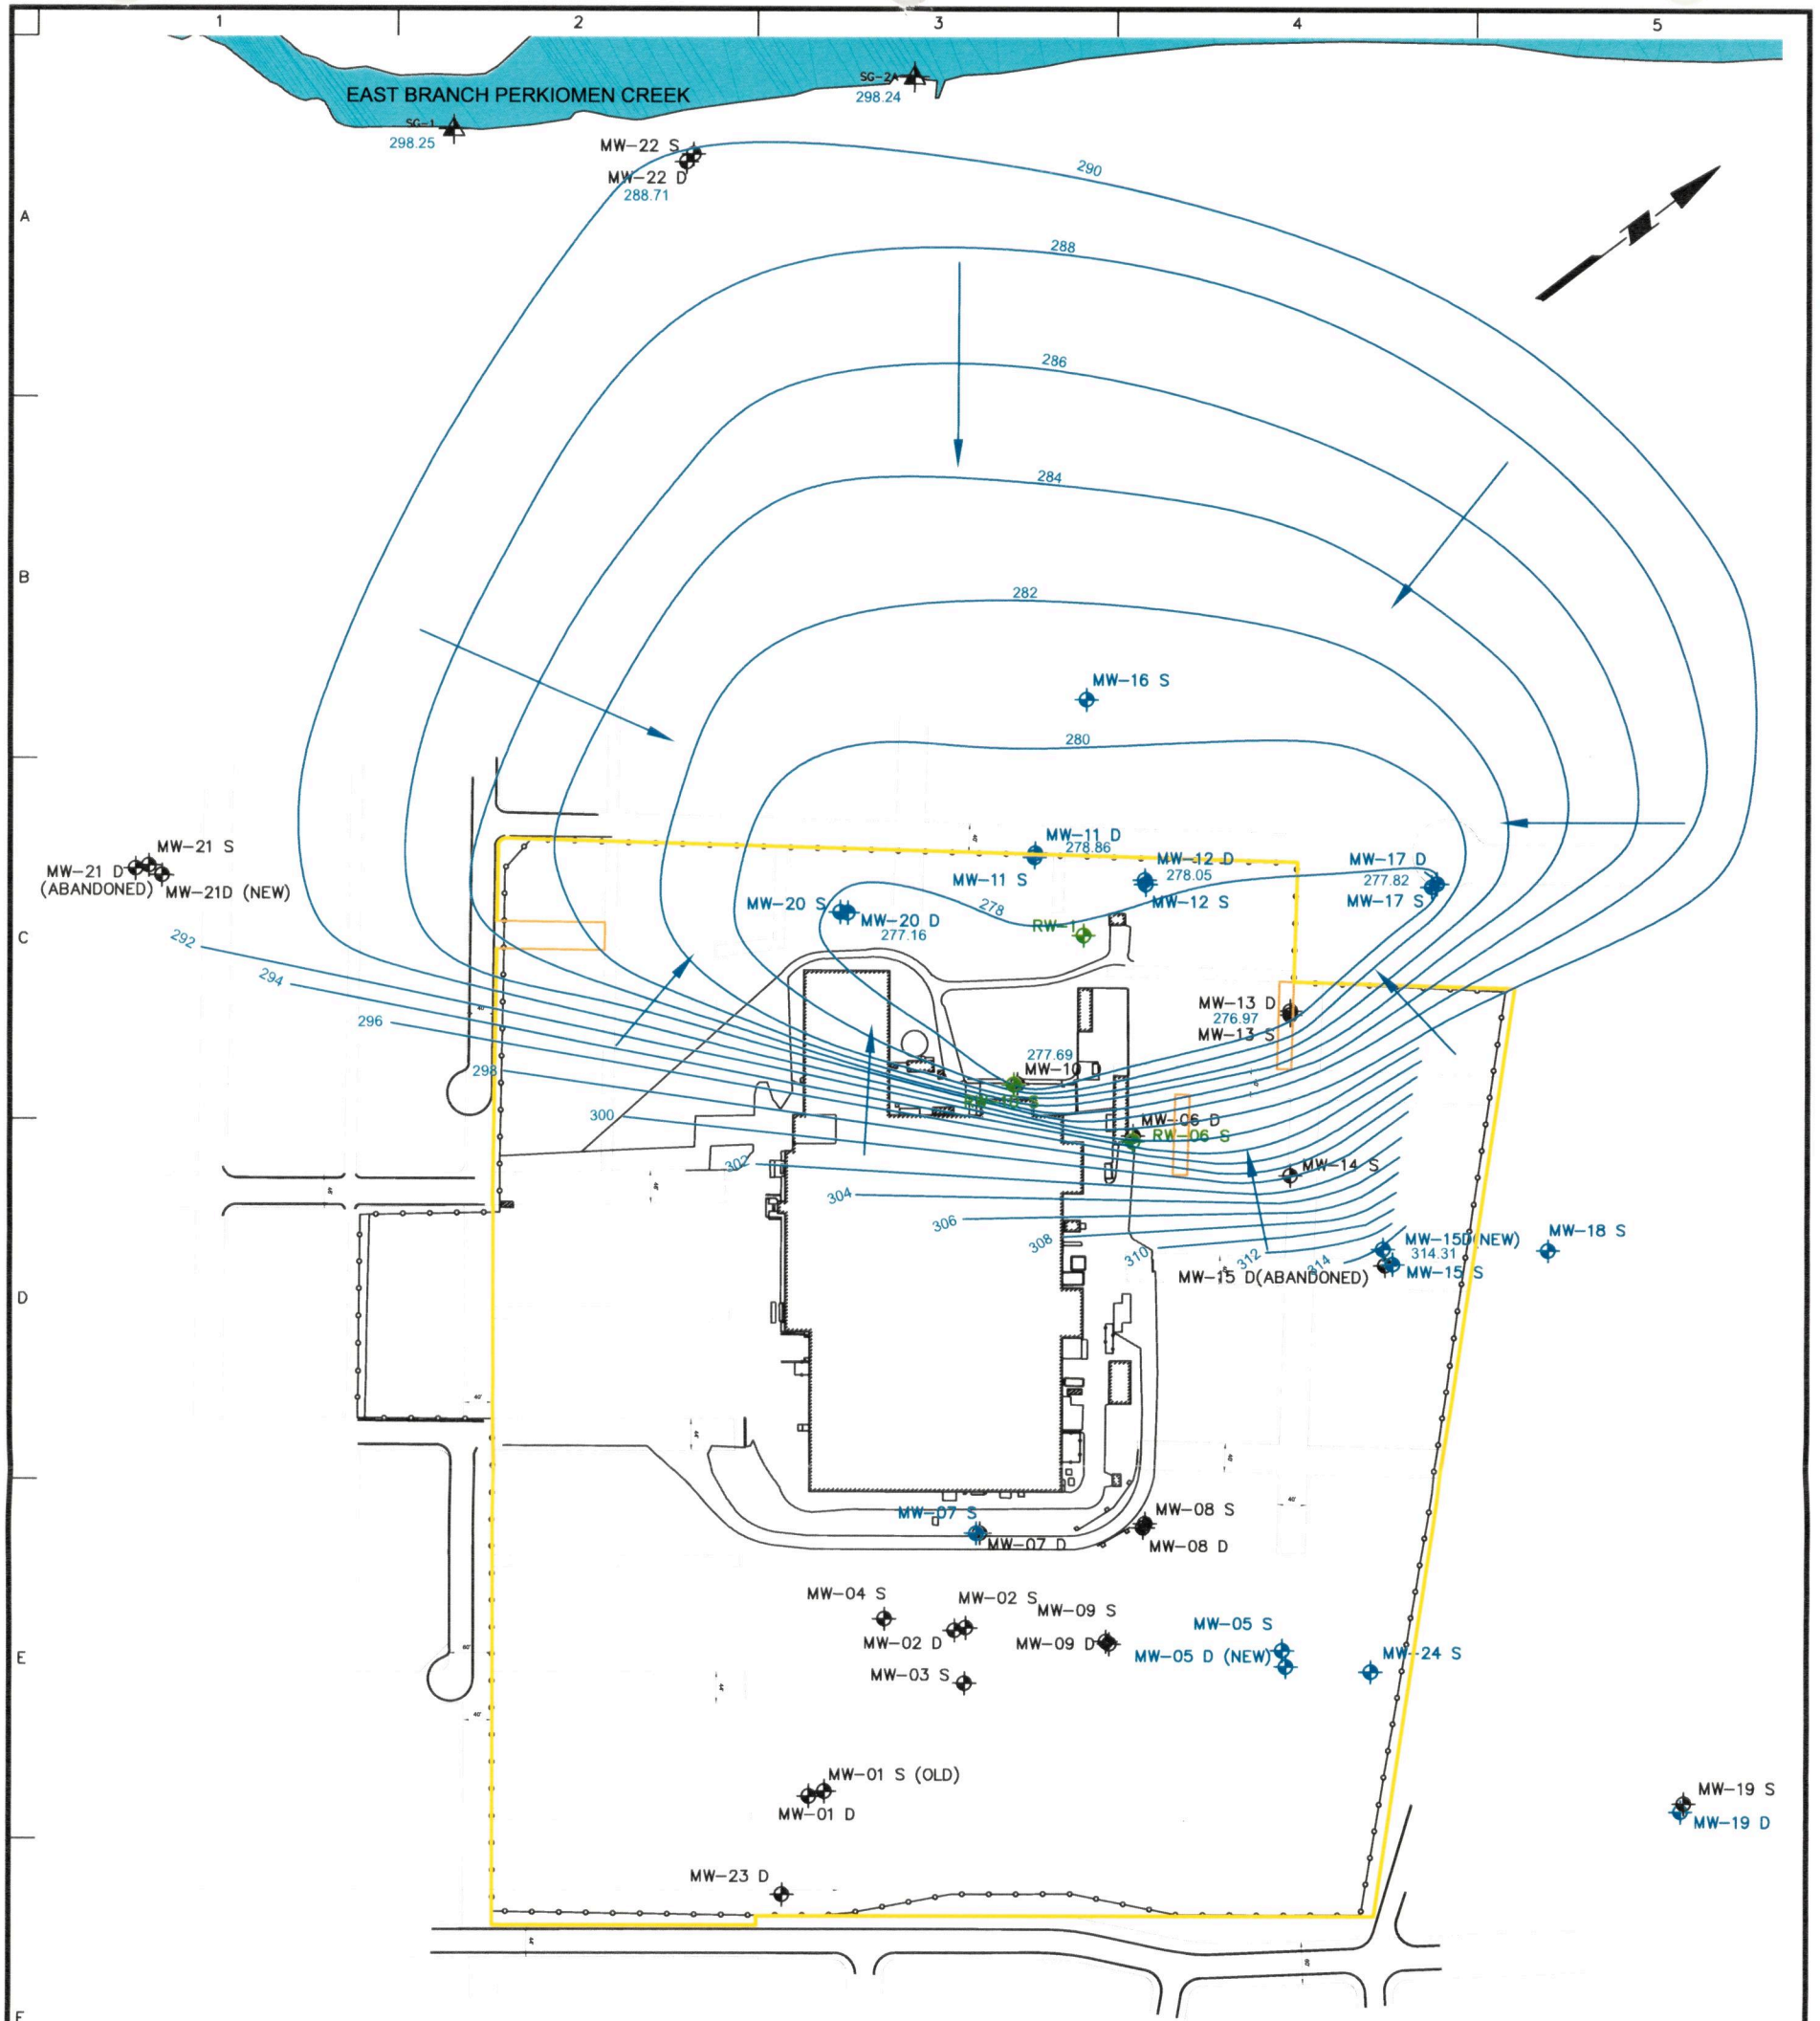
**DEEP AQUIFER (NORTH)
GROUNDWATER
CONTOURS
APRIL 2014**

- 1) NEW SITE WIDE BASEMAP SURVEY WAS SURVEYED BY TAYLOR WISEMAN & TAYLOR ON NOVEMBER 2011.
- 2) SOME MODIFICATIONS HAVE BEEN MADE TO THE GROUNDWATER MODELING SYSTEM VERSION 5.0 OUTPUT (CONTOURS) BASED ON SITE GEOLOGY AND KNOWLEDGE OF SITE CONDITIONS.

- 3) RW-1, MW-6S, & MW-10S ARE ACTIVE IRM SYSTEM GROUNDWATER RECOVERY WELLS.
- 4) MW-1S(NEW), MW-5D, AND MW-14D WERE ABANDONED AND REPLACEMENT WELL MW-5D(NEW) WAS INSTALLED, APRIL 2005 AS RECOMMENDED IN THE FINAL LETTER REPORT ON THE ADDITIONAL ENVIRONMENTAL INVESTIGATION ACTIVITIES CONDUCTED IN JULY 2004.
